Wetland and Jurisdictional Non-wetland Resources within Rose Canyon

Project/Site:	Rose Canyon Mitigation Plan	Date:	02September2004
Applicant/Owner:	City of San Diego	County:	SD
Investigator:	Kyle L. Ince, Adam H. Behle	State:	CA
Do normal circumstances exist on the site?		<input checked="" type="checkbox"/> Yes	<input type="checkbox"/> No
Is the site significantly disturbed (Atypical Situation)?		<input type="checkbox"/> Yes	<input checked="" type="checkbox"/> No
Is the area a potential Problem Area?		<input type="checkbox"/> Yes	<input checked="" type="checkbox"/> No
(If needed, explain on reverse.)		Community ID:	SWS
		Transect ID:	DP2
		Plot ID:	PP2

**Photo Point 1. Data Point 1, located in coastal sage scrub upland.**

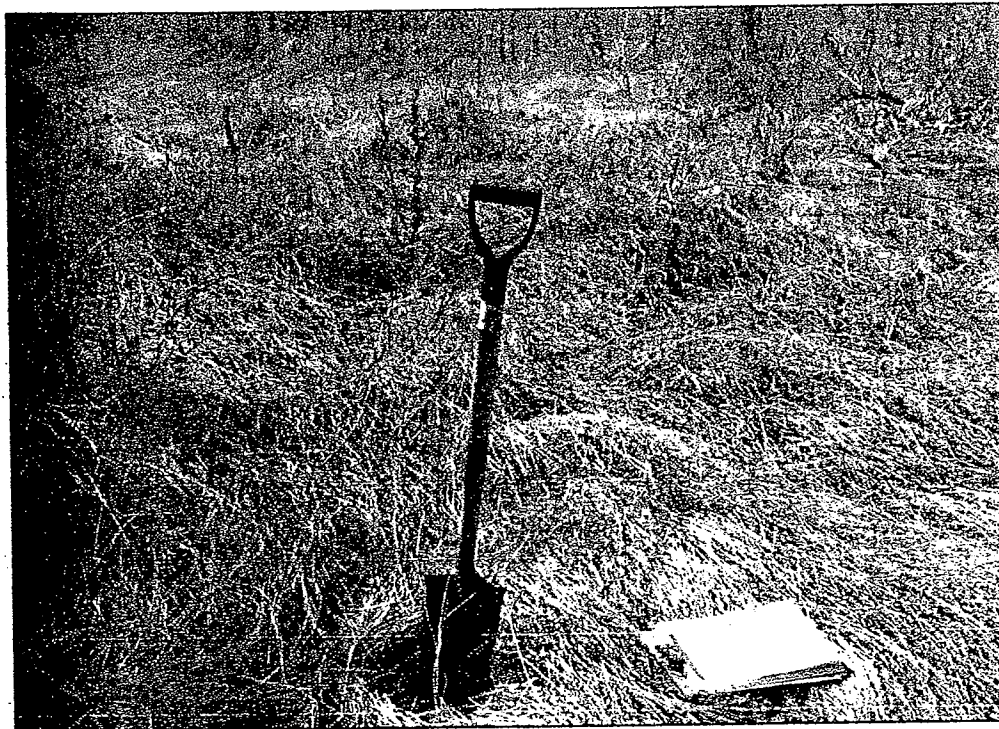
Remarks: Data point located in isolated stand of southern willow scrub vegetation with understory of herbaceous non-native species.

Remarks: Hydrology not readily apparent. Lone willow likely irrigated by surficial water flow/seepage. Water stained leaves in understory.

**Photo Point 3.** Data Point 3, located in isolated southern willow scrub vegetation.

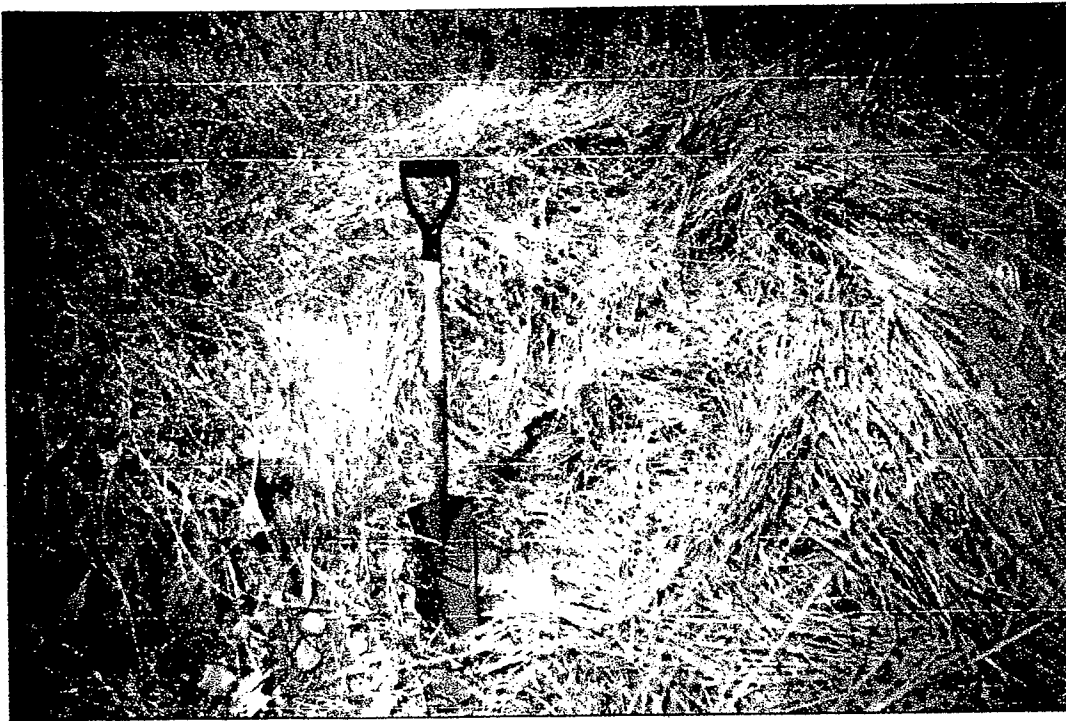
Remarks: Data point located in native grassland (wet meadow) dominated by hydrophytic vegetation.

Remarks: Data point located in area of native grassland dominated by hydrophytic vegetation. Area is jurisdictional only under the City of San Diego.

**Photo Point 4.** Data Point 4, located in native grassland (wet meadow) vegetation. This area is jurisdictional under the City of San Diego only.

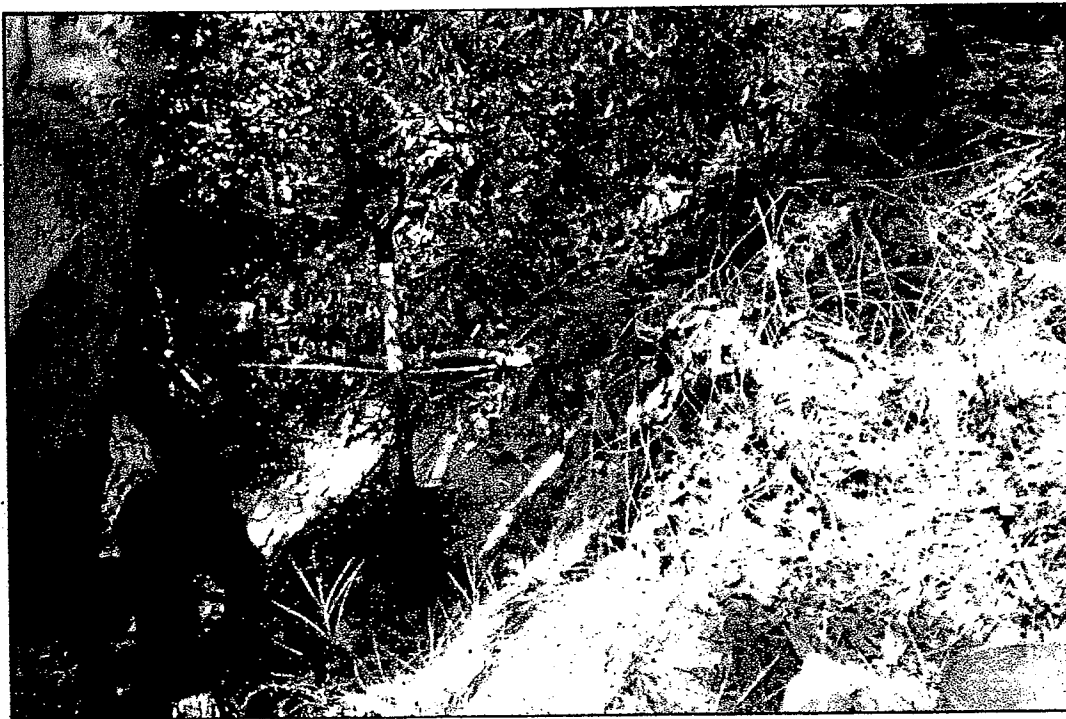
Remarks: Data point located in non-native grassland lacking hydrophytic vegetation.

**Photo Point 5.** Data Point 5, located in non-native grassland.

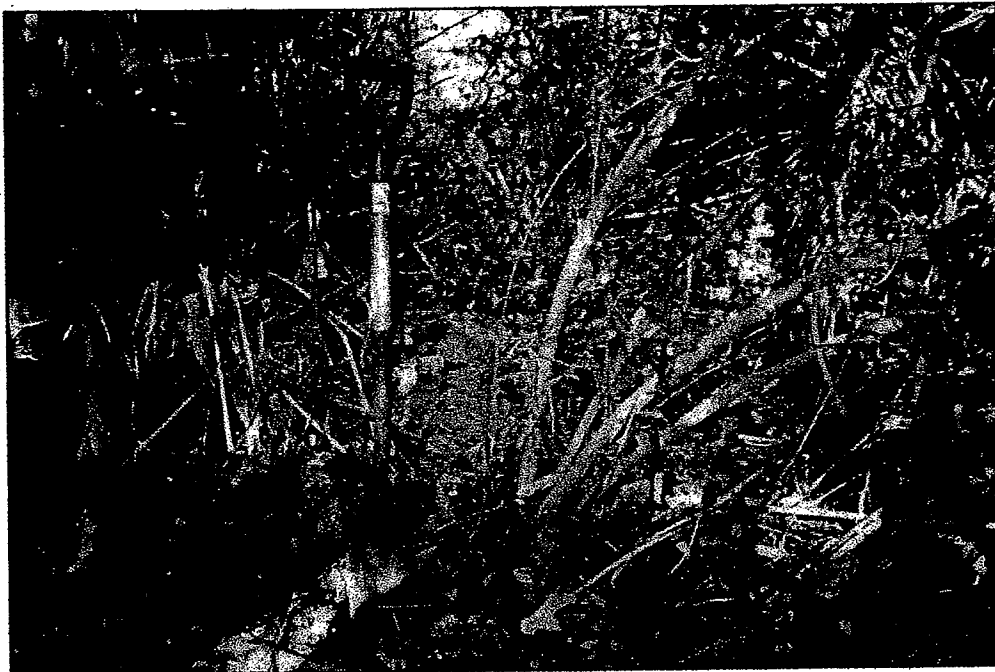
Remarks: Data point in southern cottonwood willow riparian forest consisting entirely of wetland vegetation.

**Photo Point 6.** Data Point 6, located in southern cottonwood-willow riparian forest understory.

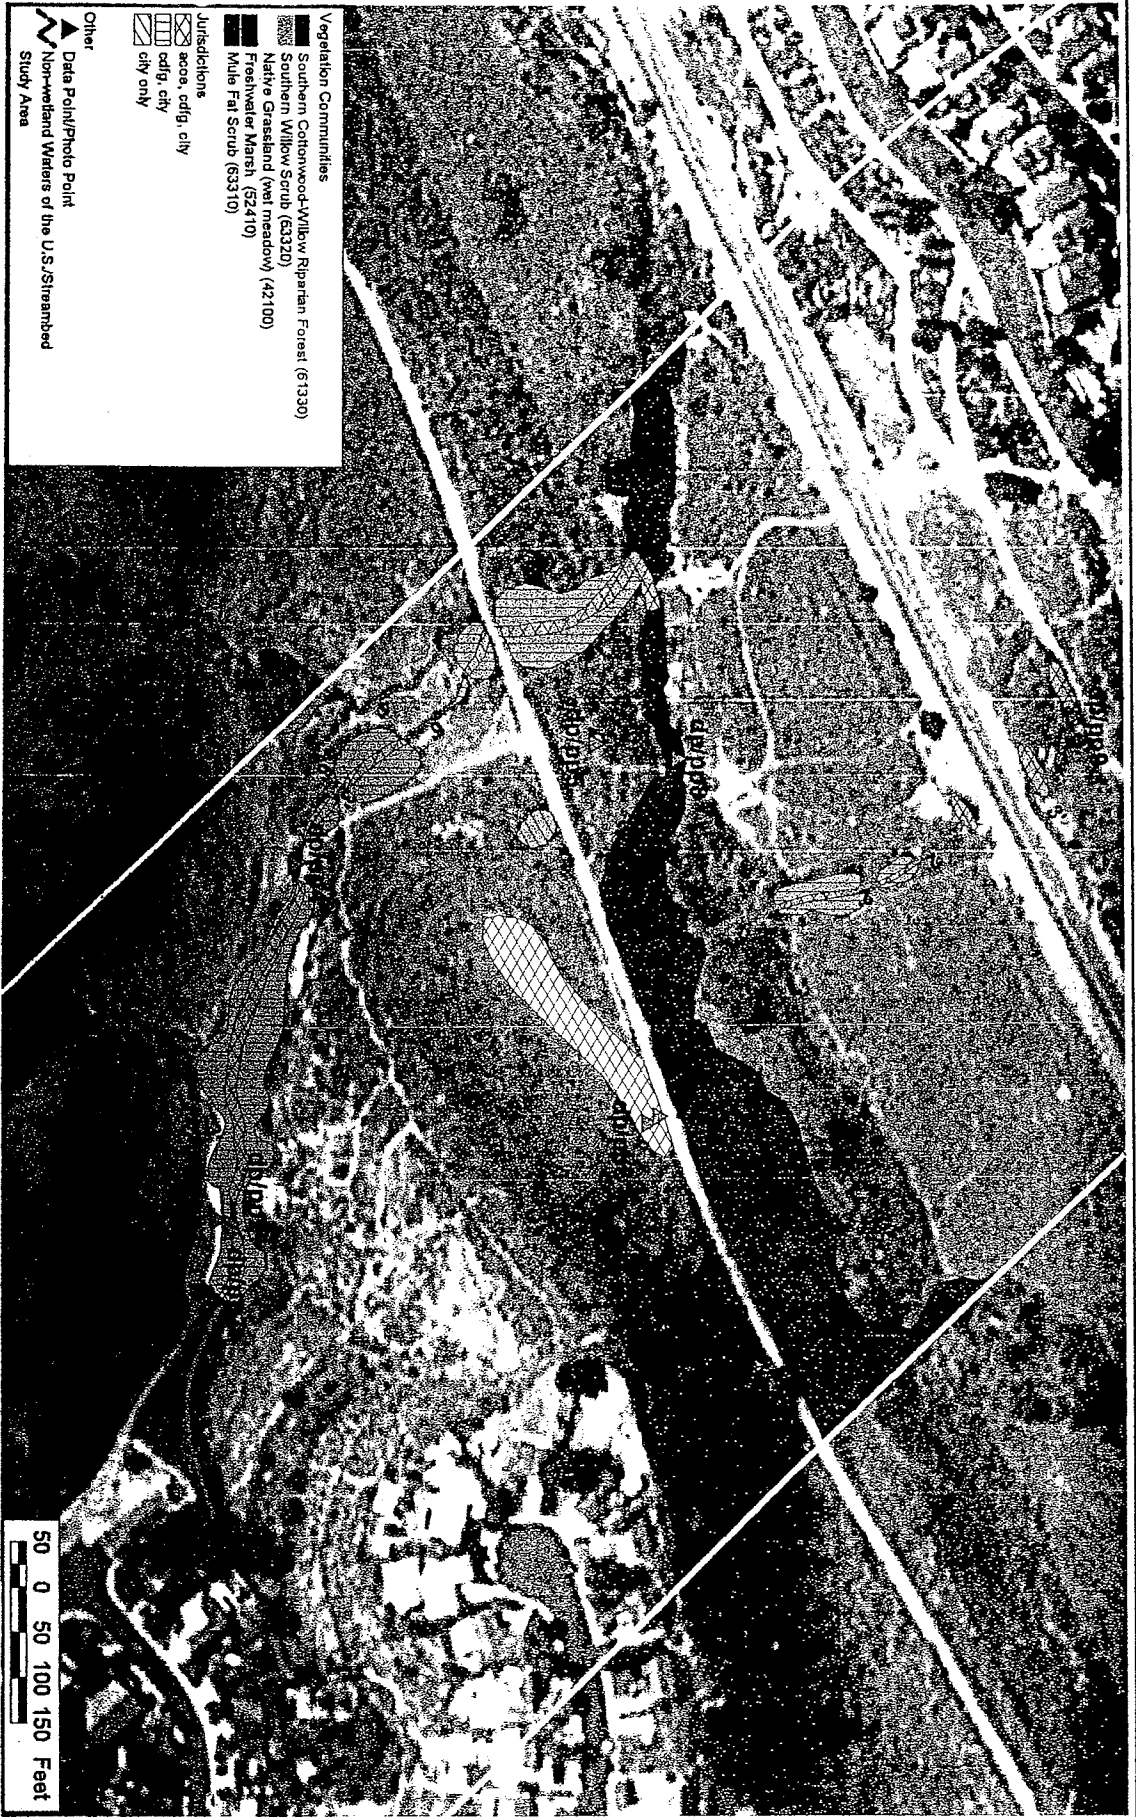
**Figure 4a**

**Regents Road Corridor (Rose Canyon) Jurisdictional Habitats/Waterways**  
University City Transportation Corridor

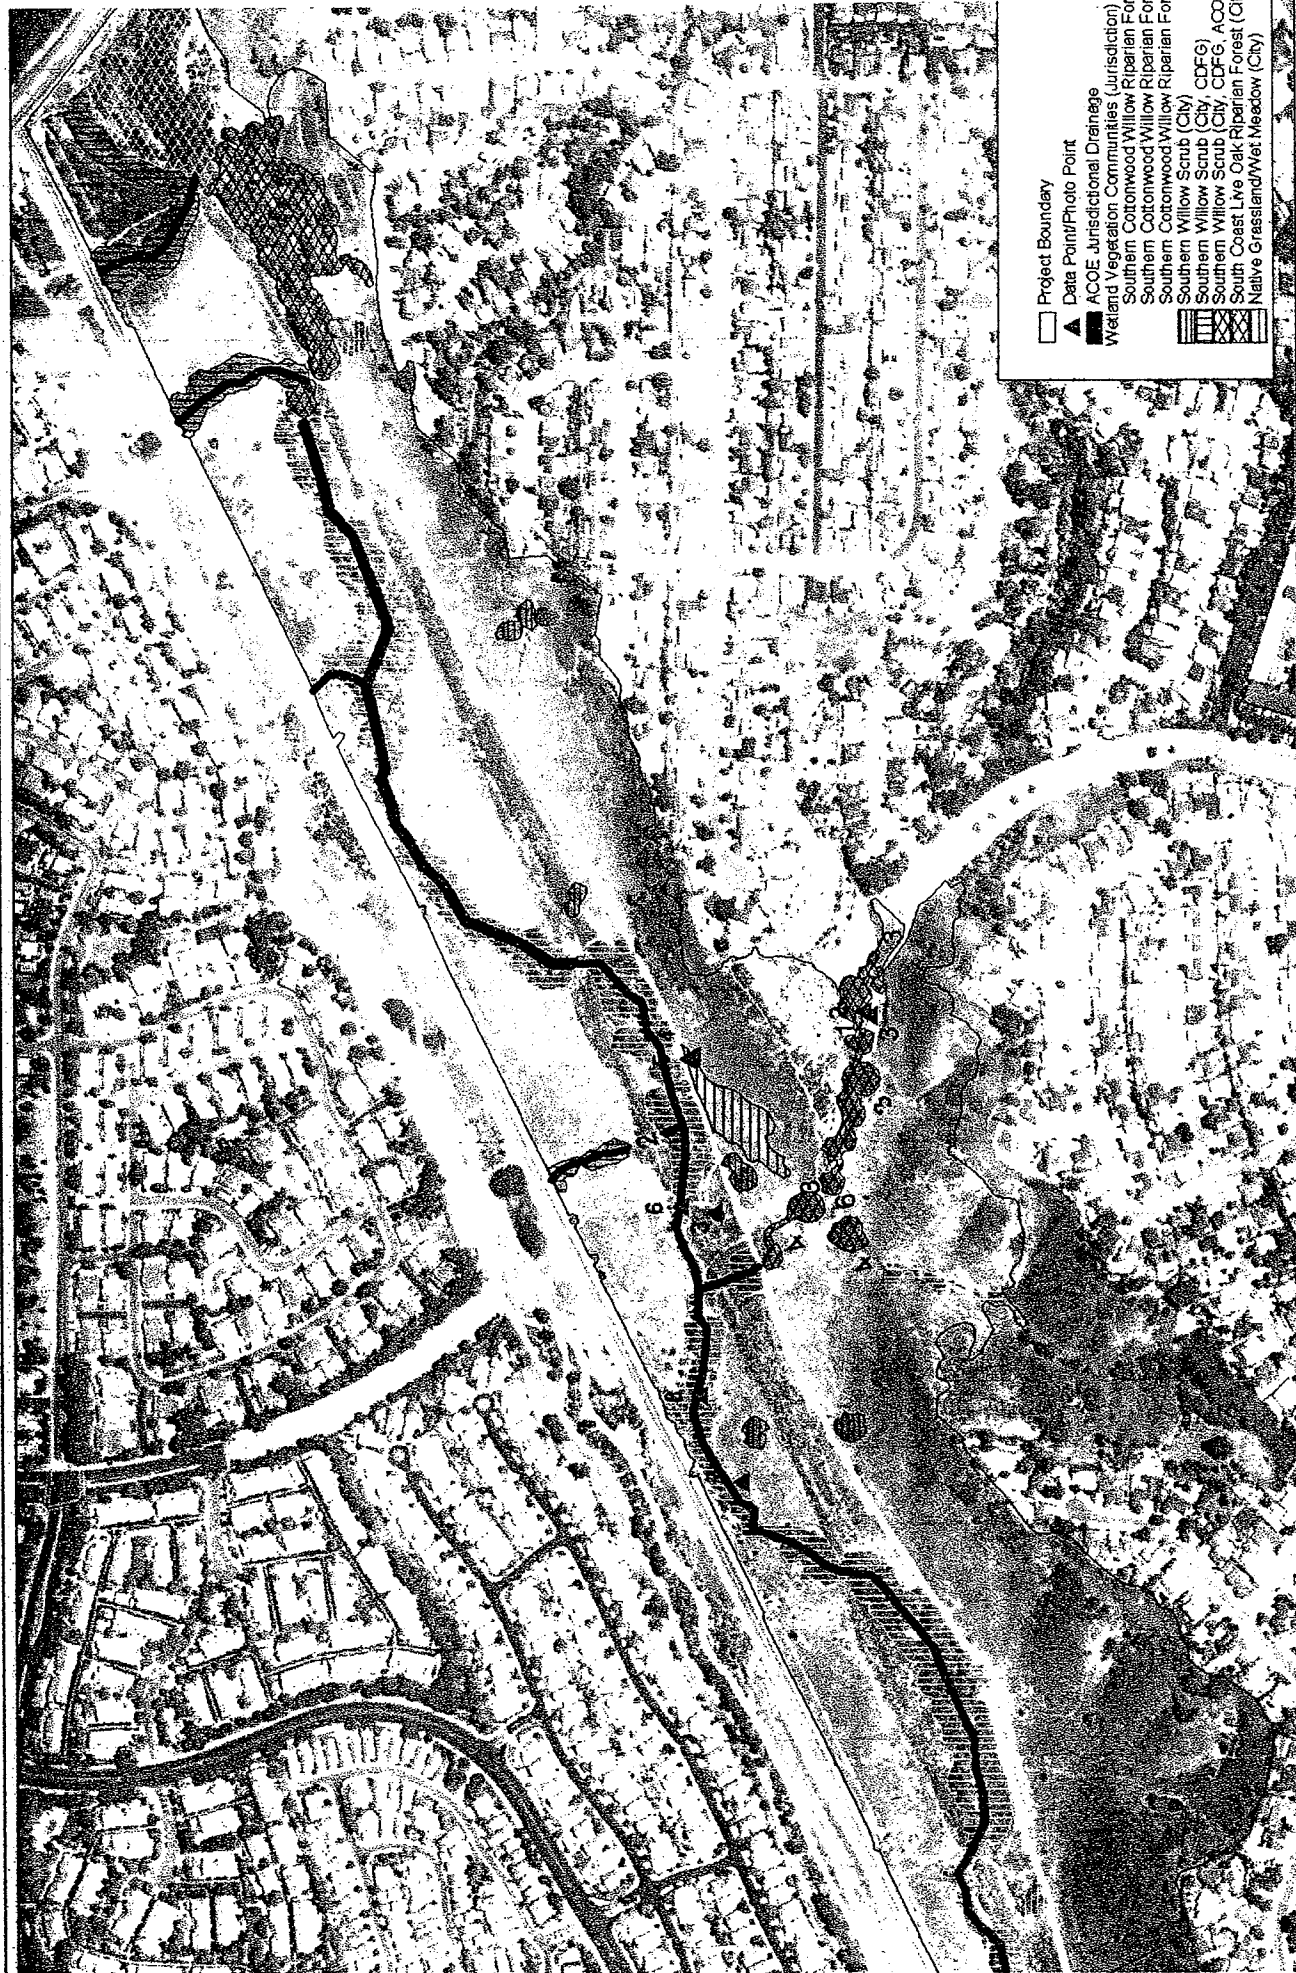
Wetland and Jurisdictional Non-wetland Resources within Rose Canyon

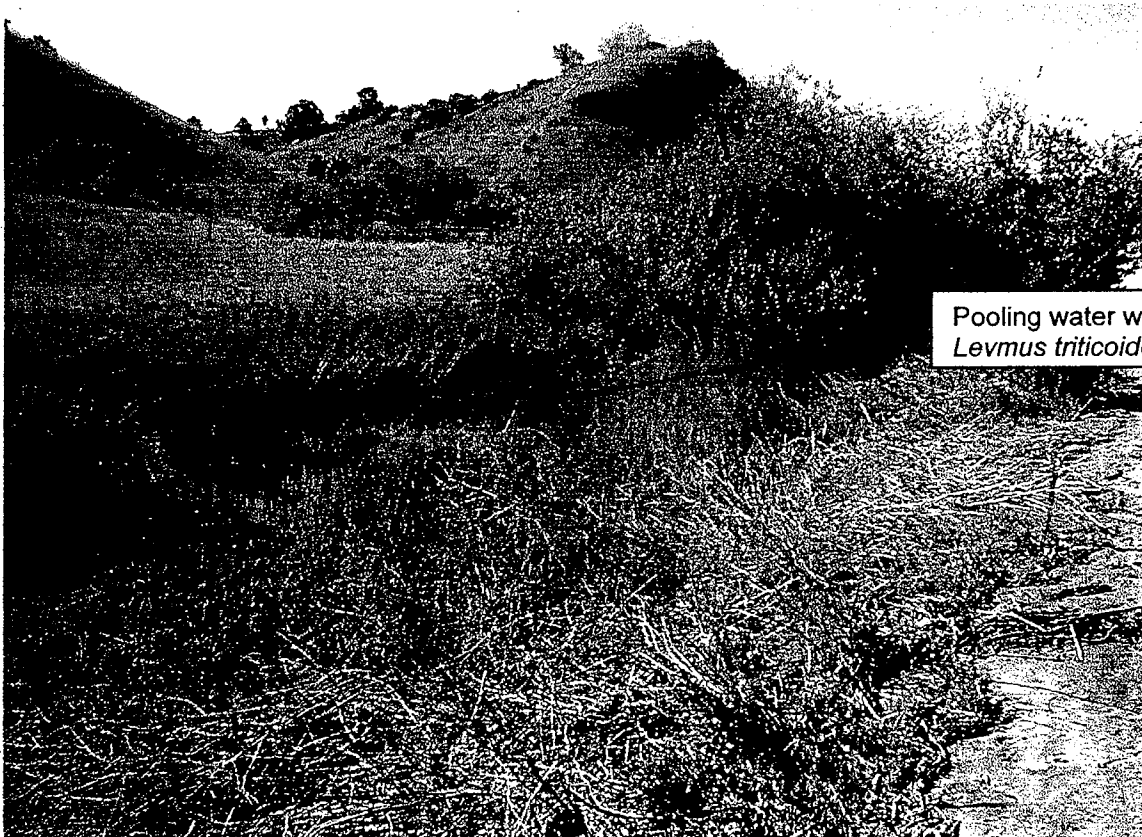
Pooling water with *Rumex*,  
*Levmus triticoides*. SWS. etc.

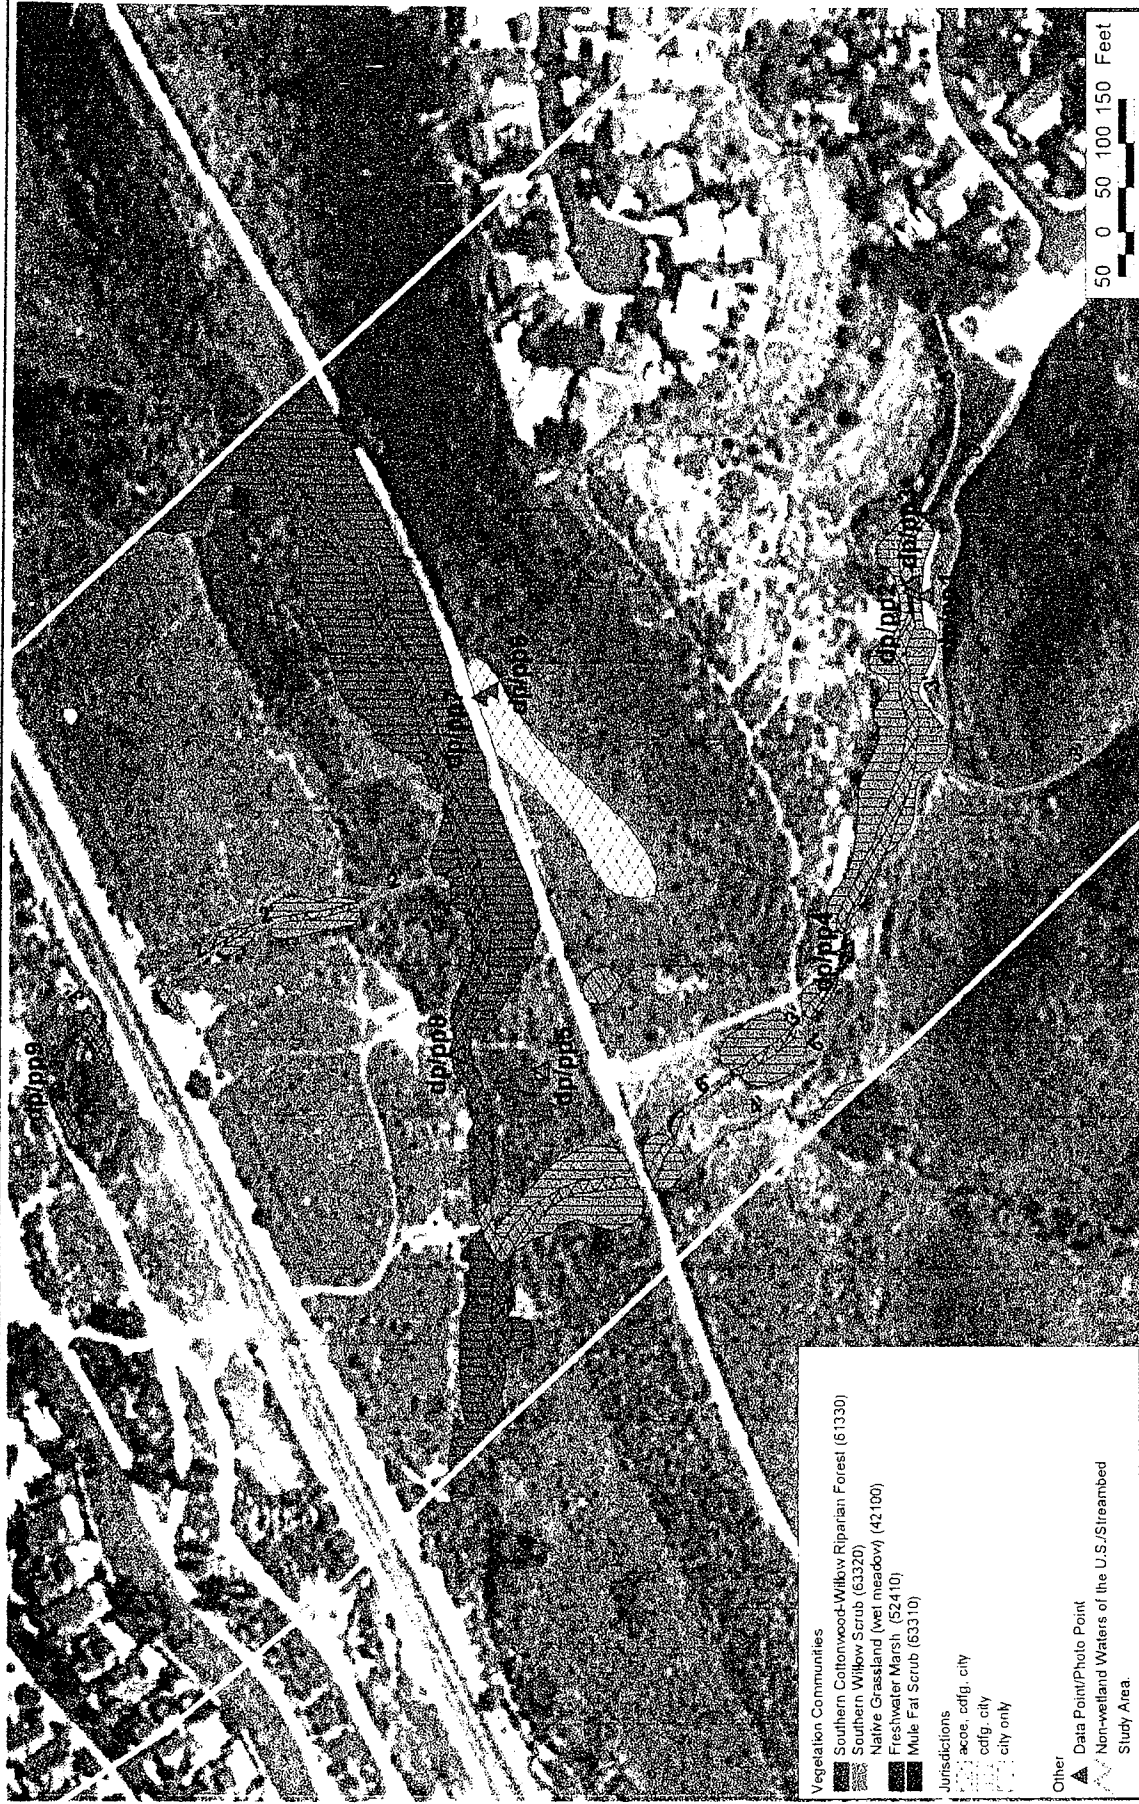
**Figure 4a**

**Regents Road Corridor (Rose Canyon) Jurisdictional Habitats/Waterways**  
University City Transportation Corridor

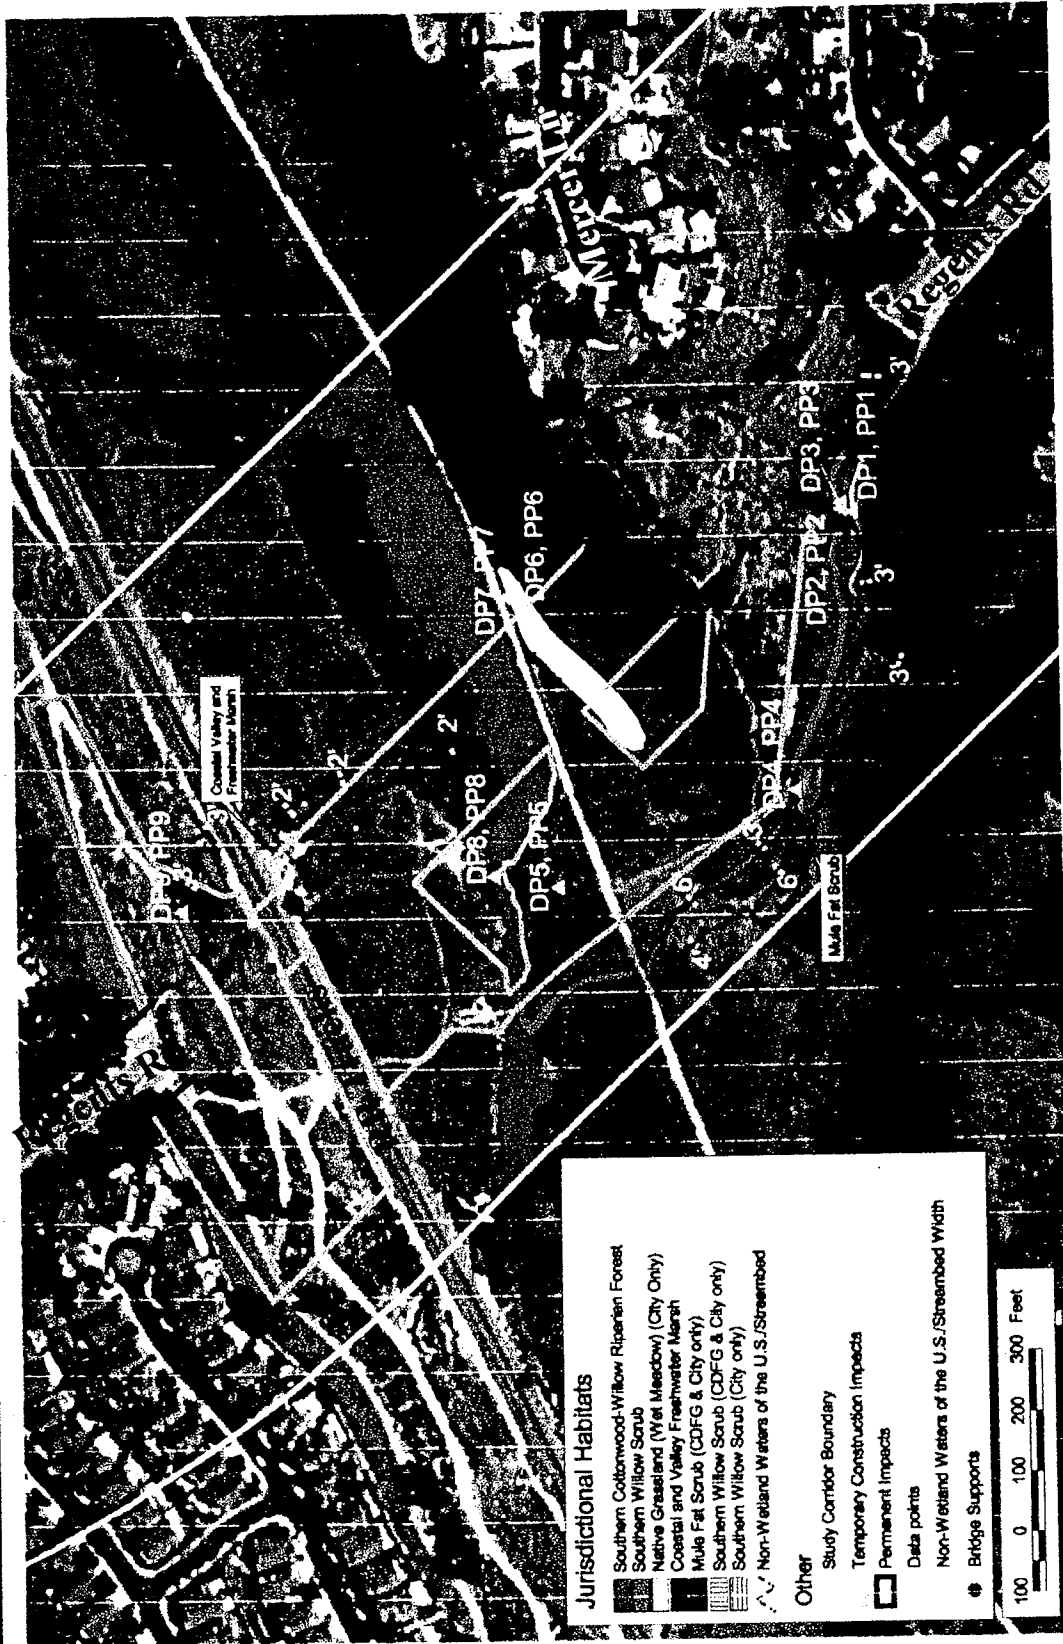
ACOE, CDFG, and City of San Diego Jurisdictional Wetlands and Waterways, Regents Road Corridor (Rose Canyon) Figure 4.3-5A
